# **APPENDIX A**

## **Implications of Recent Seismic Hazard Studies at LANL**

**Larry Goen**

## IMPLICATIONS OF RECENT SEISMIC HAZARD STUDIES AT LANL

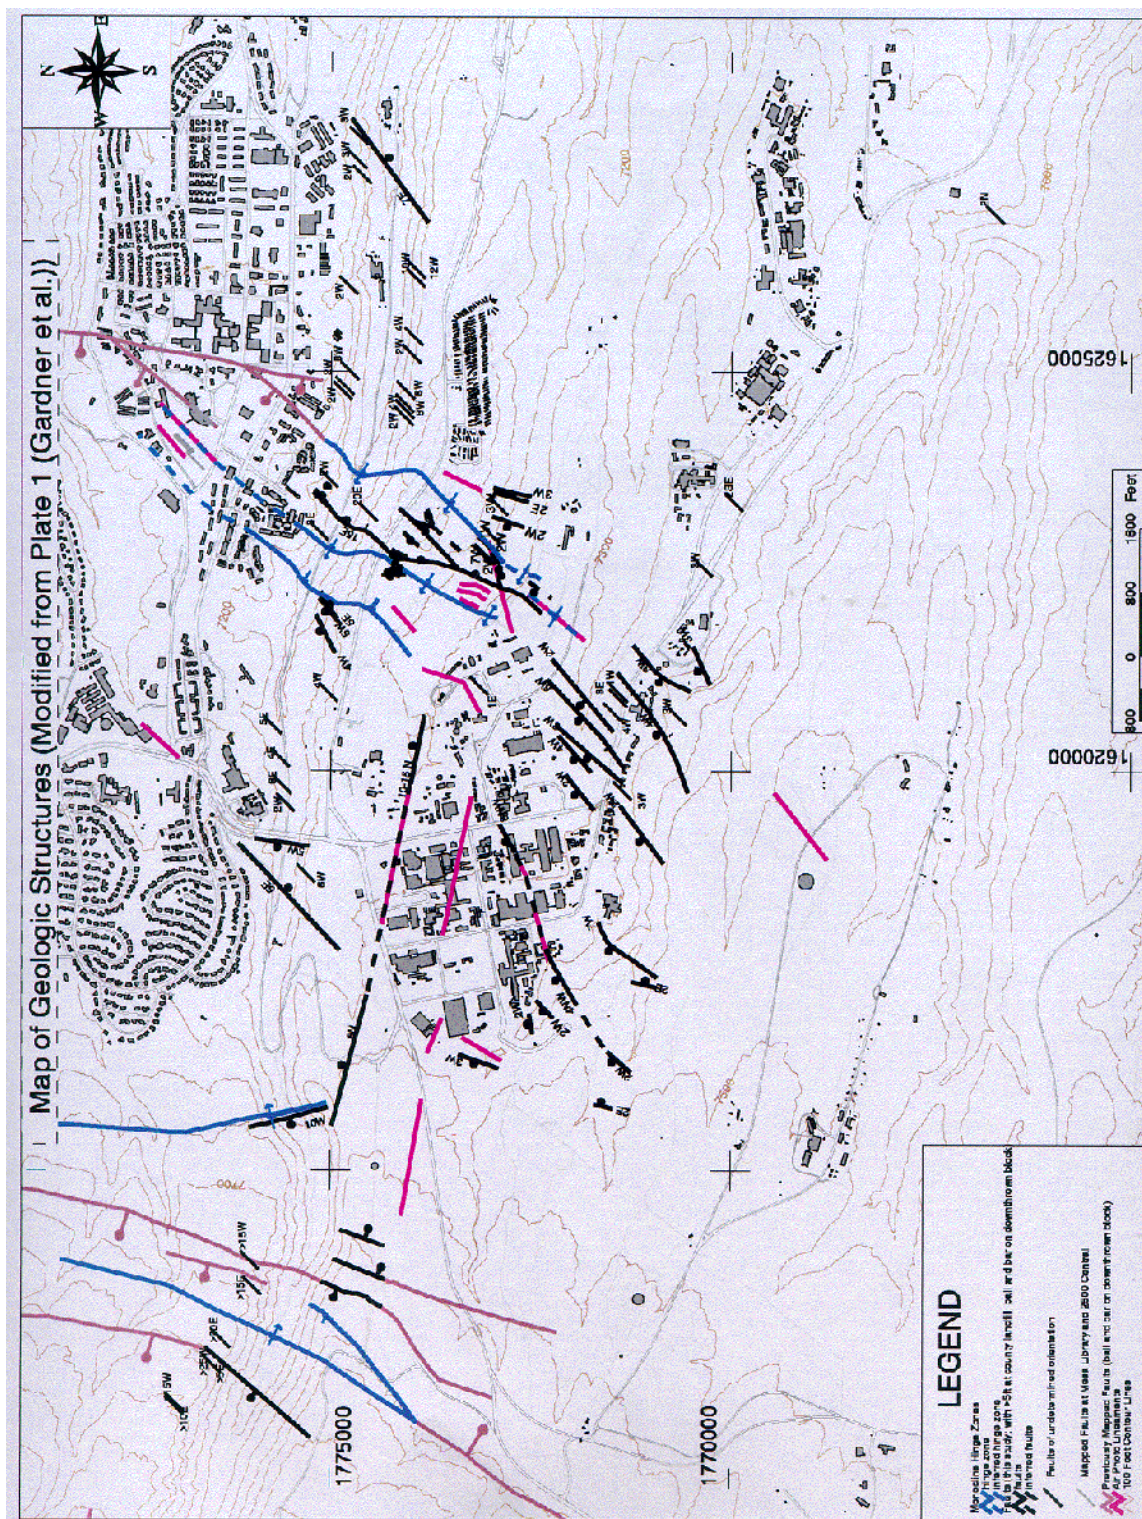
**Figure 2 –Map of Fault Location in TA-3 (Reference 13)**

Figure 2 depicts the location faults found from TA-55 to TA-3 along with linear features found in the examination of air photos dating to the 1940's. The majority of the faults found lie in the

eastern portion of TA-3, trending toward the southwest. The faults form a zone of vertical deformation which appears to be defining the southern end of the Rendija Canyon fault.

The fault zone increases in width as it progresses southward from approximately 2,000 feet at Los Alamos Canyon at the northern edge of the study to approximately 5,000 feet at Twomile Canyon at the southern edge of the study. The net vertical displacement across the zone as well as the amount of vertical displacement across individual faults gets smaller as the faults extend to the southwest. The net displacements decrease from approximately 100 feet at Los Alamos Canyon to less than 30 feet at Twomile Canyon with individual faults being less than about 10 feet. All of the displacements on these faults occurred over the last 1.22 million years.

The linear features from air photos could indicate linear features such as fences trails and roads but could also indicate the location of faults. These linear features were initially used as guides in the data gathering and analysis portions of this study. As can be seen in the figure, some of the lineaments do coincide with faults found in conjunction with this study, while others are located where no evidence for faulting has been found. It should be noted that the one air photo lineament trending to the northwest through the middle of TA-3 has been identified as a fault on the construction drawings for Buildings TA-3-42 and TA-3-200 but could not be verified in this study.

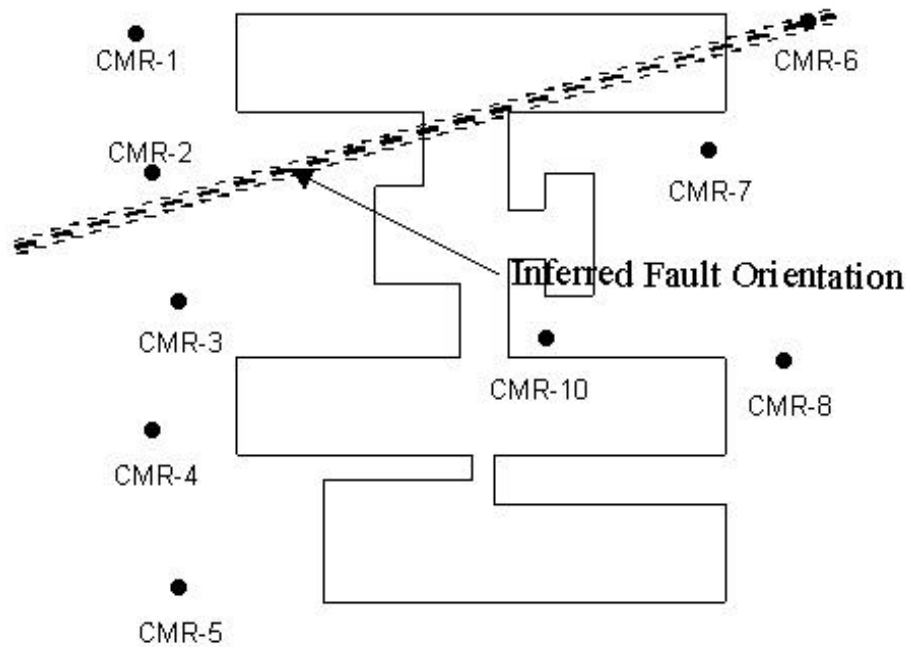
**Figure 3 – Plan View of CMR Building With Inferred Location of Fault**

Analysis (Ref. 4) of the data obtained indicates that a fault is present at the CMR Building. Its location and inferred orientation are shown in Figure 3. The fault is contained within the core obtained from the CMR-6 and can be inferred to occur between the CMR-2 and CMR-3 locations. This orientation is consistent with one of the air photo lineaments shown in Figure 2 and faults found in Twomile Canyon (Ref. 13). The total displacement of the faulted stratigraphy in the CMR-6 core is approximately 8 feet in the last 1.22 million years.

Based on this investigation, it can be concluded that the CMR Building site has, in the past, been impacted by fault rupture. However, as discussed later in this report, the probability of an earthquake causing significant surface displacement at this site in the future is small.

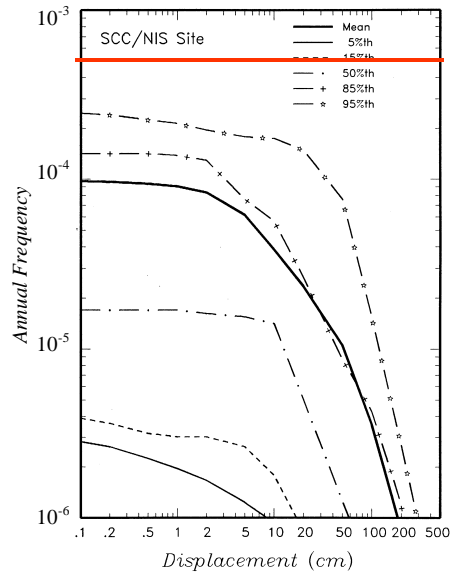
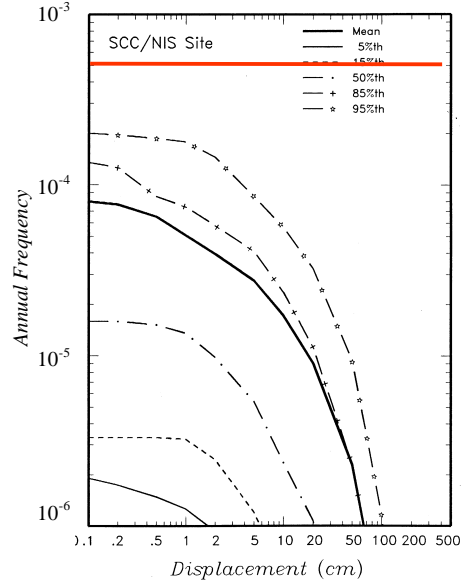
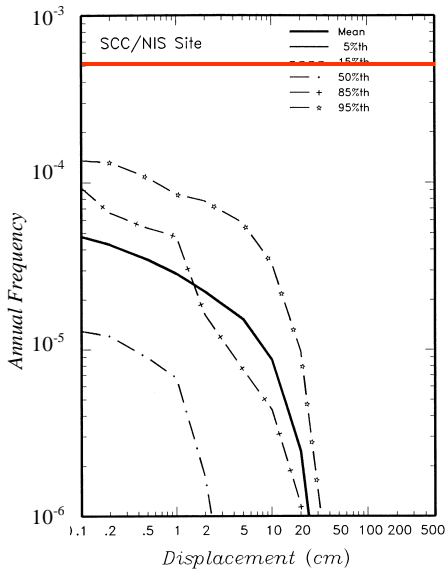
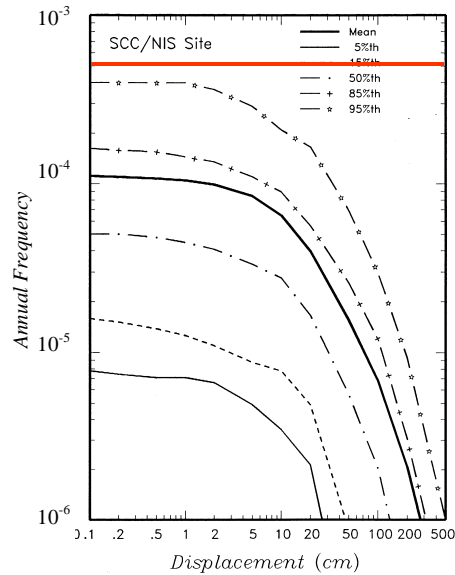
**Figure 4 – Surface Rupture Hazard Curves for the SCC/NISC Site (Performance Goal for Performance Category (PC) 2 Facilities is  $5 \times 10^{-4}$ )**

The results, summarized in Table 2, show that for annual frequencies of  $10^{-4}$  or larger, surface rupture is minimal or nonexistent. The hazard curves developed for the two sites are shown in Figures 4 and 5. Hazard curves that investigate the sensitivity of the three main faults being connected or not are shown in Figure 6.

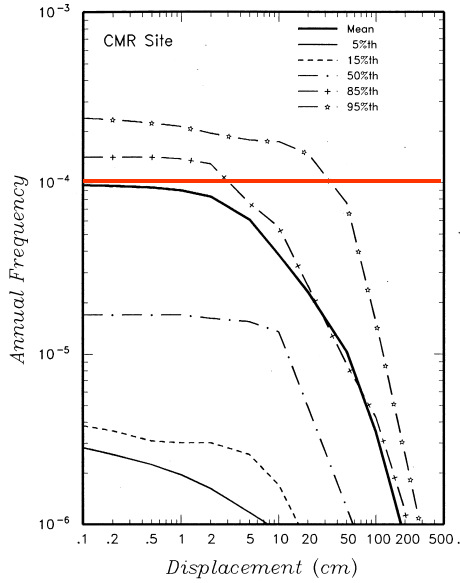
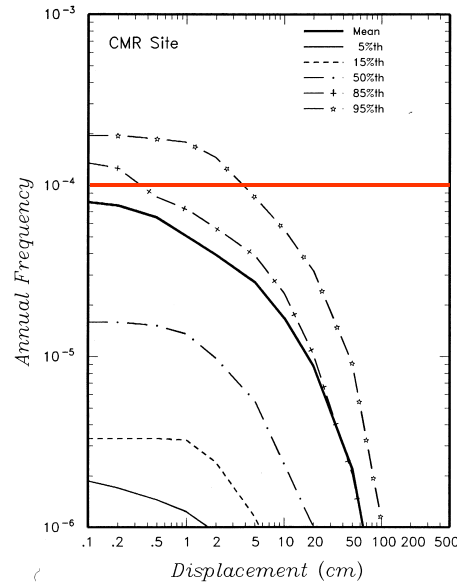
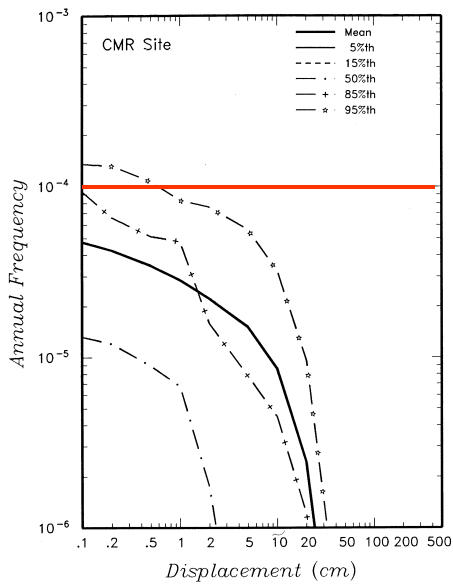
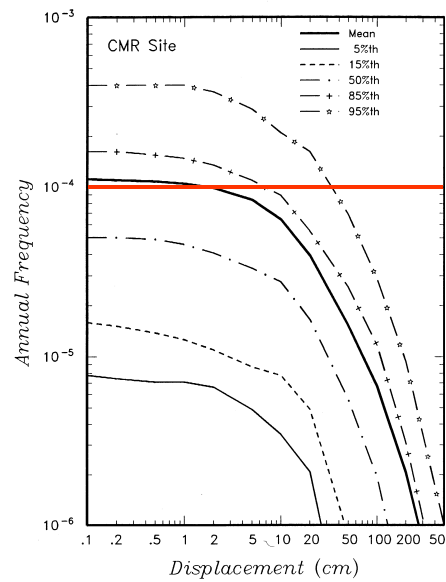
**Figure 5 – Surface Rupture Hazard Curves for the CMR Building Site (Performance Goal for Performance Category (PC) 3 Facilities is  $1 \times 10^{-4}$ )**

For existing facilities, hazard curves developed in the probabilistic surface rupture study (Ref. 6) for TA-3 are used. At the performance goals for PC 1 and PC 2,  $1 \times 10^{-3}$  and  $5 \times 10^{-4}$ , respectively, the estimated displacement for any of the cases as shown in Figures 4 and 5 and summarized in Table 2 is less than 1 millimeter. This is true even for the case where all faults are assumed to be connected. This small amount of displacement has a negligible effect on structures. Therefore, for existing PC 1 and PC 2 facilities, surface rupture is not a credible hazard and the only aspect of the seismic hazard at TA-3 that should be considered is ground motion.

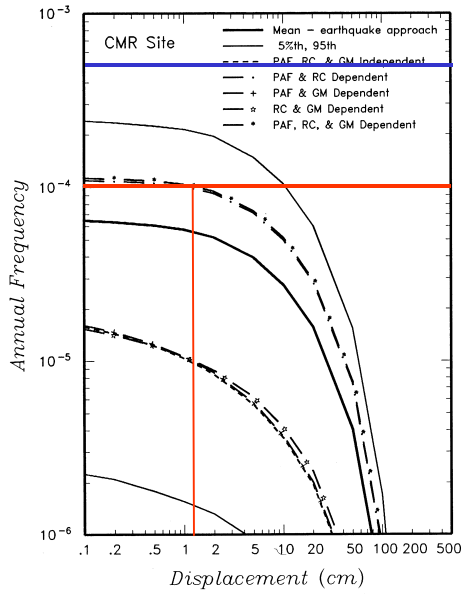
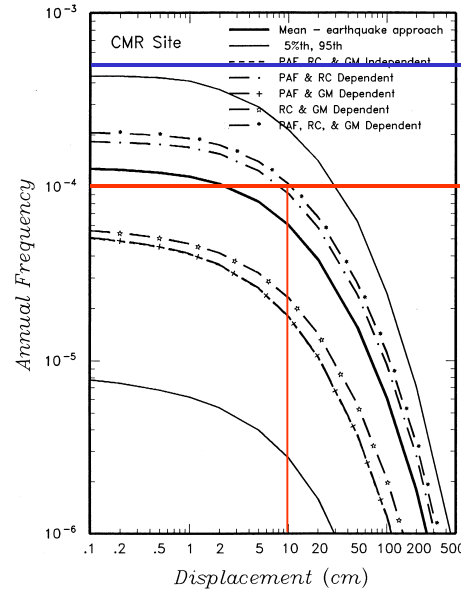
**Figure 6 – Surface Rupture Hazard Curve Sensitivity Results (Illustrates the effects of assuming fault dependency on hazard curves.)**

However, if the worse case assumption is made that this is a principal fault and that all three faults are connected, the estimated offset from Figure 6 for the PC 3 performance goal is approximately 10 centimeters (4 inches). A displacement of this magnitude can cause significant cracking in a concrete shear wall structure such as those used in the construction of the CMR Building. This cracking could result in a loss of confinement.

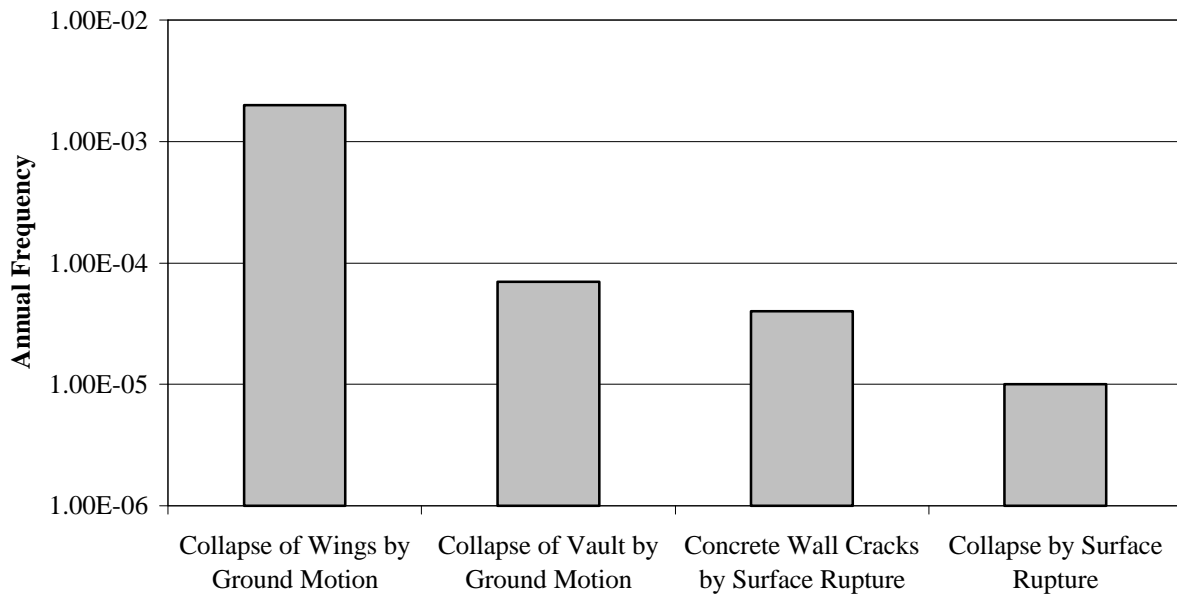
**Figure 8 – Frequency of Seismic Induced Damage at CMR Building**

It can be shown (Ref. 12) that the annual probability of seismic induced failure, based on ground motion associated with an earthquake, is about  $2 \times 10^{-3}$  for most areas of the CMR Building. The exceptions to this is the vault that has an annual probability of seismic induced failure, again, based on ground motion, of about  $7 \times 10^{-5}$ , and the floor wells which have yet a lower probability of failure. The significance of this information is that ground motion could cause a loss of confinement for most areas of the CMR Building at frequency that is at least 20 times greater than surface rupture.

Based on the information from the referenced studies, the fault under the CMR site is a subsidiary fault. As a result, any movement on the fault is likely to be small and would be a result of a large (Magnitude 6 to 7) earthquake on the Rendija Canyon or the Pajarito fault. Such earthquakes are low probability events. In Figure 8 the estimated annual frequency of damage caused by ground motion is compared to the annual frequency of damage caused by surface rupture. This figure illustrates that damaging surface rupture is far less likely to occur than damaging ground motion.
